Historical Record: “The Port Chicago, California, Ship Explosion of 17 July 1944”

“The Port Chicago, California, Ship Explosion of 17 July 1944.” Army-Navy Explosives Safety Board Technical Paper No. 6. Washington, D.C., 1948.

Extracts from:***“The Port Chicago, California, Ship Explosion of 17 July 1944.”*****ABSTRACT.**

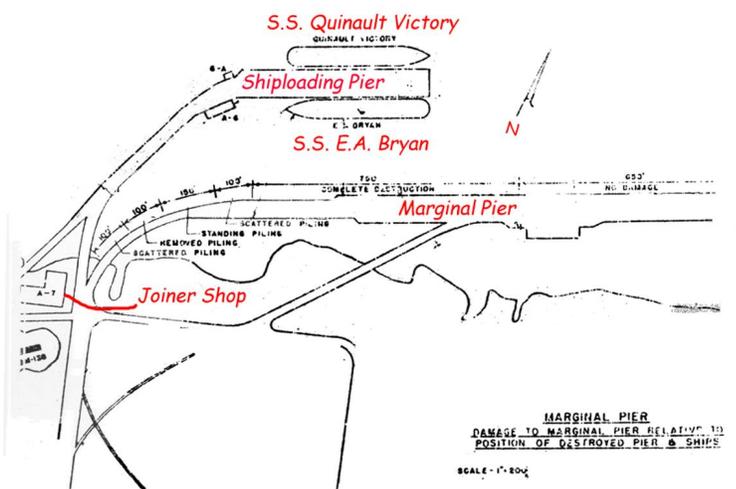
Diagram, Port Chicago Naval Magazine, ships and piers

At the approach end of the main pier was the joiner shop, and working therein were five civilians and a Marine private. In the revetment area, filled with about 140 loaded cars of ammunition and bombs, an engine crew was shifting cars for the directed needs of the pier transportation officer. Marine guards, some with trained dogs, were patrolling various posts, one of which included the approach end of the loading pier outward to the main bend.

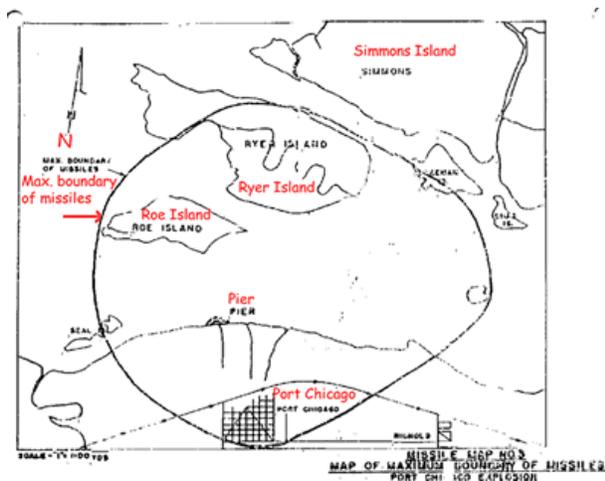
Map of maximum boundary of missiles.

Except for 200 feet of the approach end, the loading pier was destroyed along with a diesel locomotive, 16 carloads of ammunition and bombs, and a utility building 100 x 26 x 14 feet which were on it. Many missiles, recognized as parts of the railroad cars, were found on Roe Island to the north and a few were found in the vicinity of the revetments to the south. The joiner building, situated on land close to the approach to the pier and at a distance of 1,000 feet from the center of the pier was demolished but three men working therein were rescued without serious injury. These men were the closest to the explosion that

The ships, E. A. Bryan and Quinault Victory, were destroyed and the former furnished the greater part of the steel missiles which showered the area. Large pieces, later identified as parts of the hull of the Quinault Victory, were found imbedded in the muddy bottom of the bay north of the pier. One piece of keel, 60 to

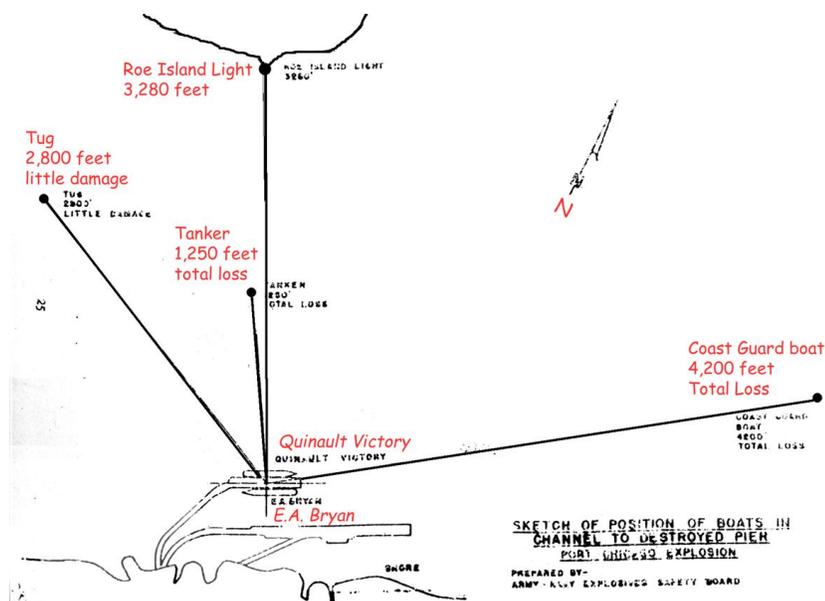
Sketch of position of boats in channel to destroyed pier.

The position of the boats to the pier at the time of the explosion is indicated by the sketch map on Page 25. The M.S. Redline sustained damage both from the blast wave and from missiles with some additional damage from the water wave. The superstructure was almost gone, all the tank tops were broken open, and the steel plates were bent, some even twisted and cut. The engine room was penetrated by a 14-inch projectile and another penetrated not only the top of the deck

house but also two bunks therein. The engine was knocked out so that it became necessary to tow the tanker to a wharf. After appraisal of the cost of repairs it was estimated that the M.S. Redline was 88 per cent
